SmartPlant Foundation Issues

SmartPlant Foundation Configuration

JBOG Integration

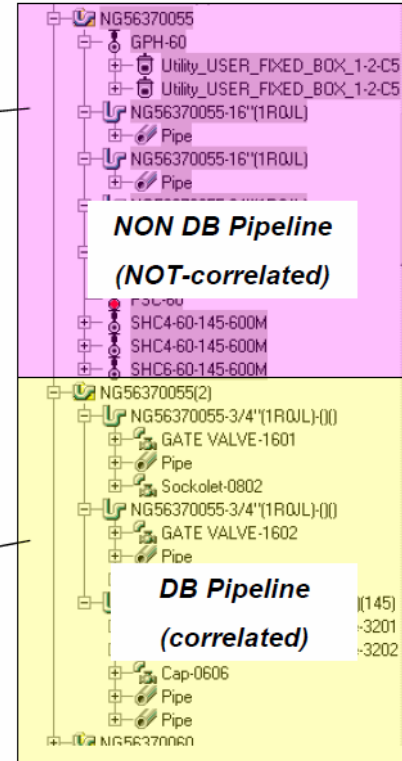
Custom detailed support assembly – built from components

Requires manual reassignment of items from NON DB Pipeline to the DB Pipeline

- Pipe Runs
- Hangers & Supports

Switch Tasks and set select filter for correct component level – OR – can set select filter to ALL from one task

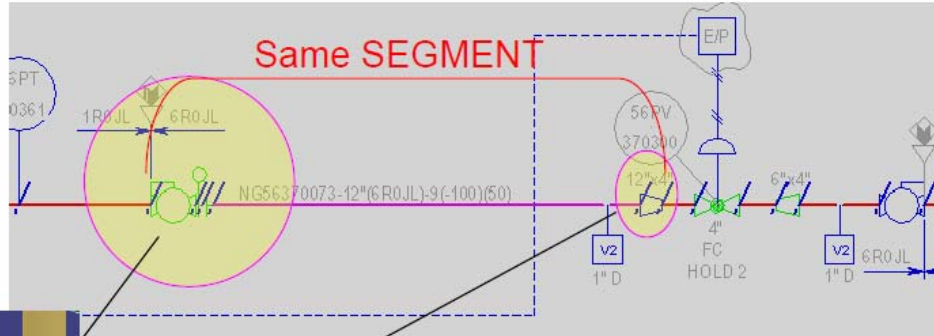
Some features Valve, blind, reducers, and flanges are not always correlated with pipe run.

Requires manual correlation at the FEATURE level of each component

Manual edit PARTS from MATING part to BASE part.

Required to manually break up 3D model pipe runs to match PID segments
